A1	Trouble-shooting chart	
-----------	------------------------	--

1. Rapid diagnosis chart

Rapid diagnosis chart
Opel trip computer

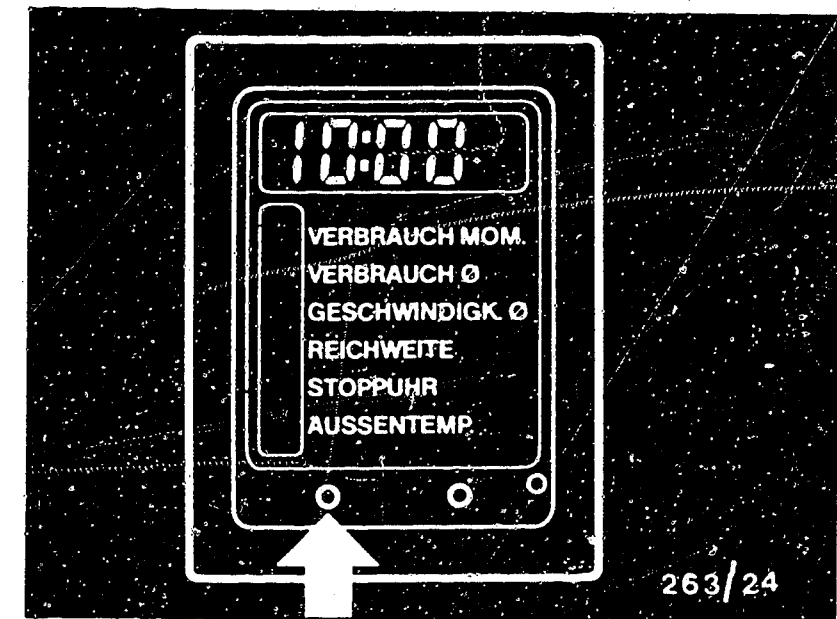
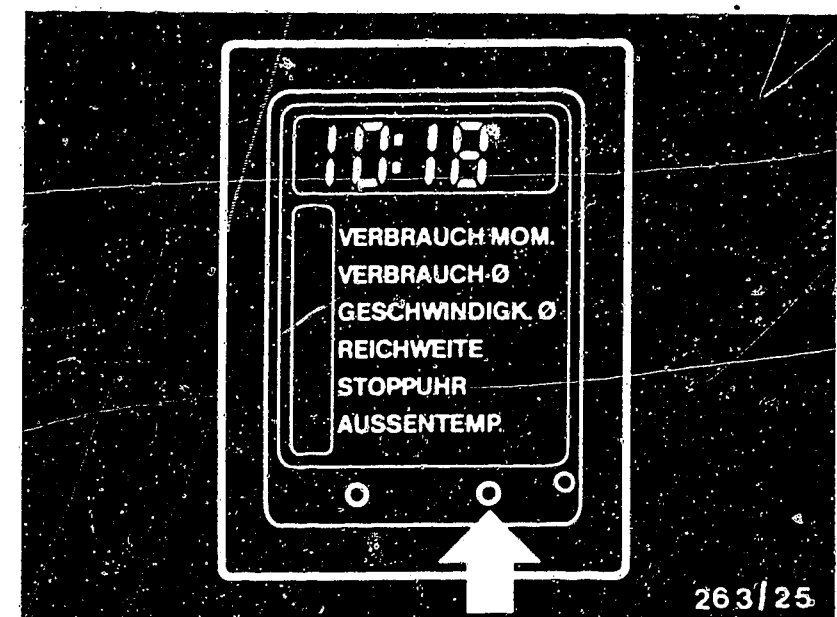
Important: In the illustration below, item 1 (illumination button) is only installed up to 6.84.

6.7 Setting the range

If the trip computer, tank sender or fuel tank has been replaced, it is necessary to re-adjust the trip computer.

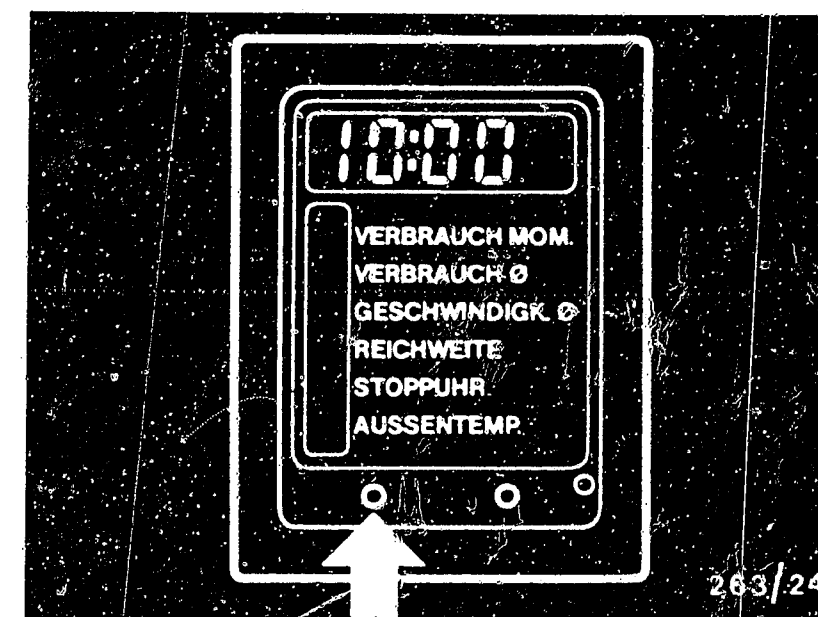
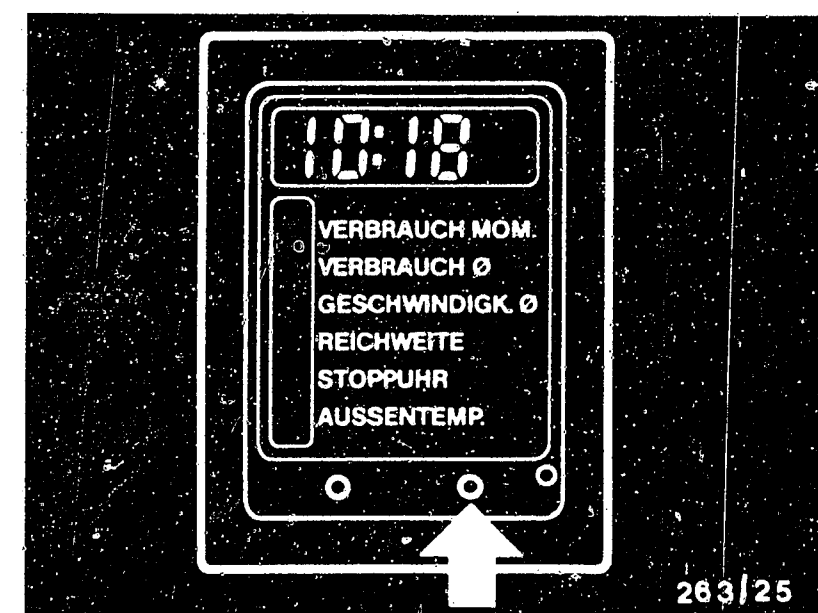
D19

Press the reset knob on the operator keyboard (bottom picture, arrow). The seconds are set to zero and the clock is started.

Dots between hours and minutes no longer flash.

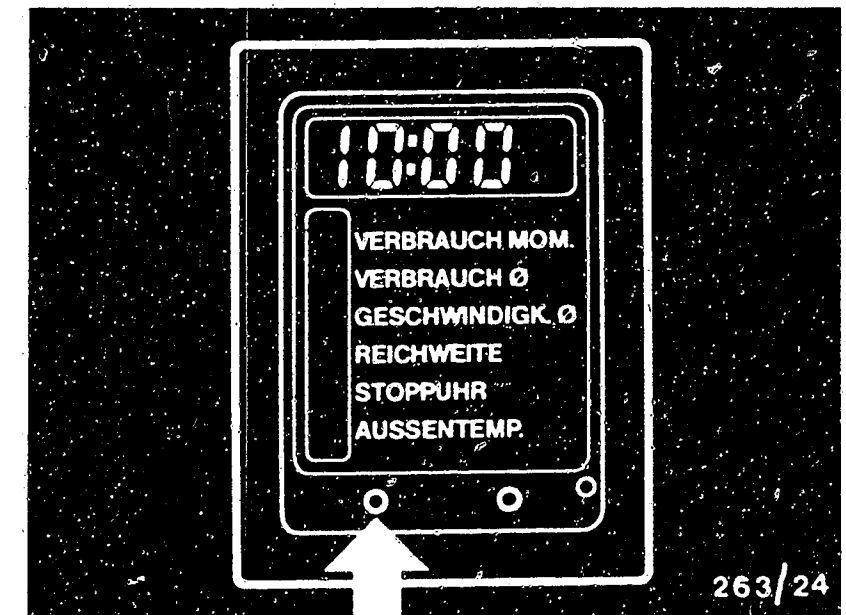
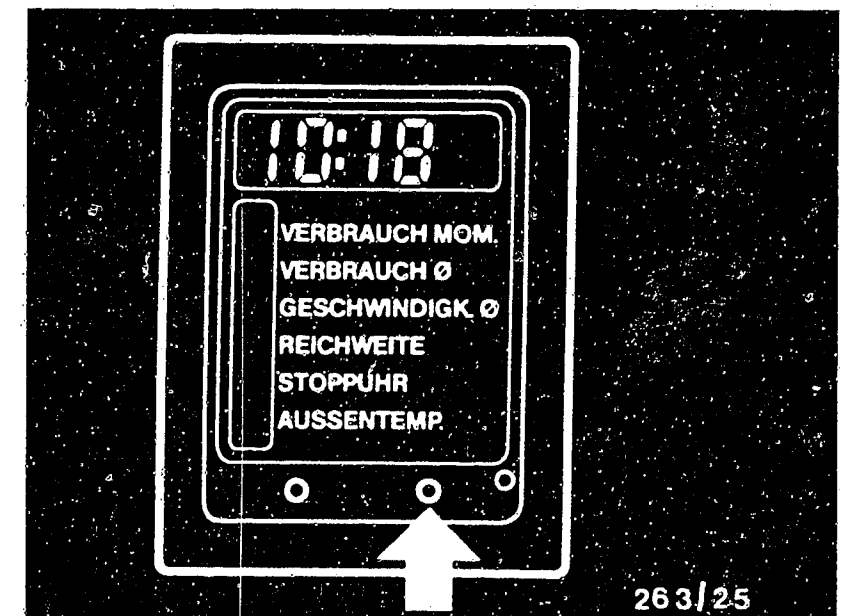
E17

Important: In the illustration below, item 1 (illumination button) is only installed up to 6.84.
